**February 17, 2021**

**Safety Recall: 2009-13 Fit Driveshaft Inspection**Supersedes 21-009, dated February 16, 2021, to revise the information highlighted **yellow****AFFECTED VEHICLES**

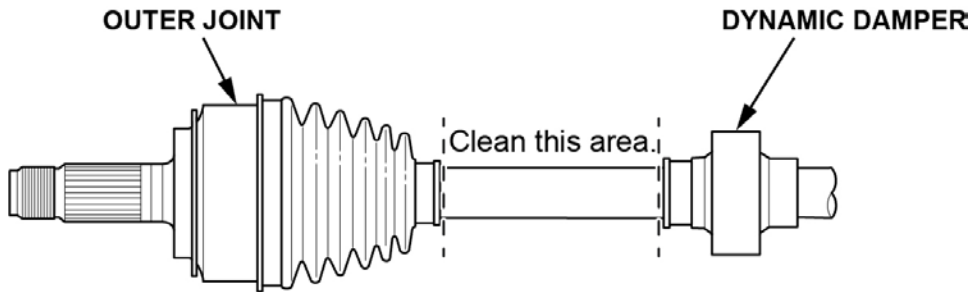
1. Raise and support the vehicle.
2. Use a clean shop towel to wipe any excess dirt and debris from the driveshafts between the outer joint and the dynamic damper.

NOTE: Paint chips may be sharp and could cut bare hands. Use gloves when wiping the driveshaft.

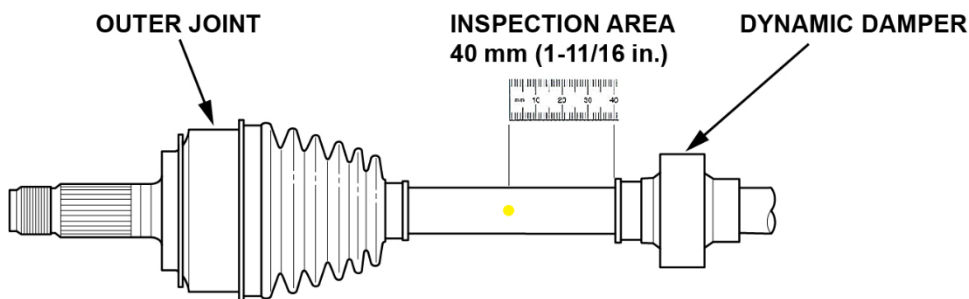
3. Using a ruler and yellow paint marker, measure **40 mm (1-11/16 in)** away from the dynamic damper, and mark the driveshaft with a dot. Click [HERE](#) to view a video on how to do the inspection procedure.

NOTE: Do not scribe or damage the painted surface of the driveshaft. Any replaced driveshafts may be called in for inspection.

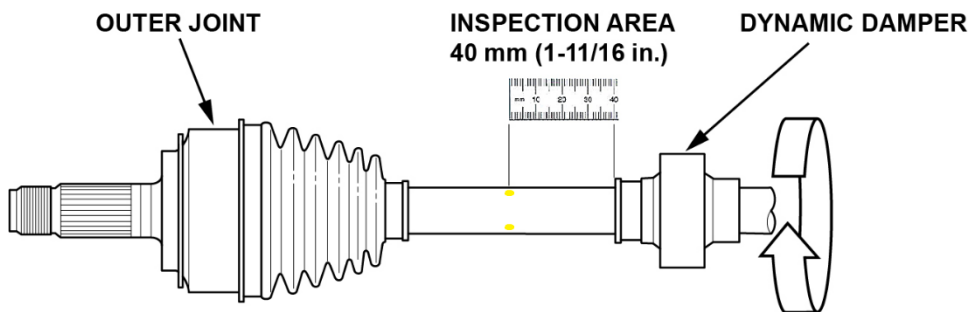
4. Rotate the axle 1/4 turn and repeat the step above **three times** until there are four paint dots on the axle.

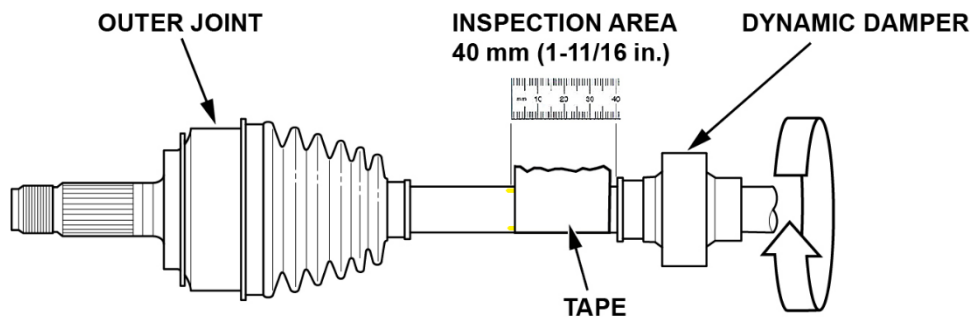
5. Connect the four painted dots around the axle using masking tape.

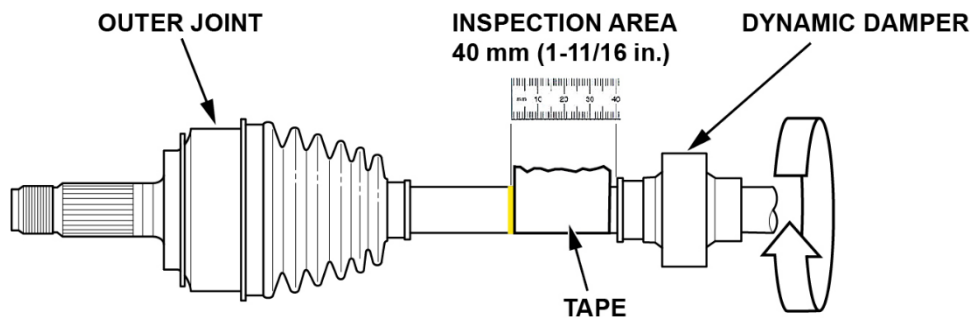
6. Using the masking tape as a guide, trace a line all around the axle using the yellow paint marker. Marking the line accurately is important, especially if there is damage close to or inside the 40 mm line.

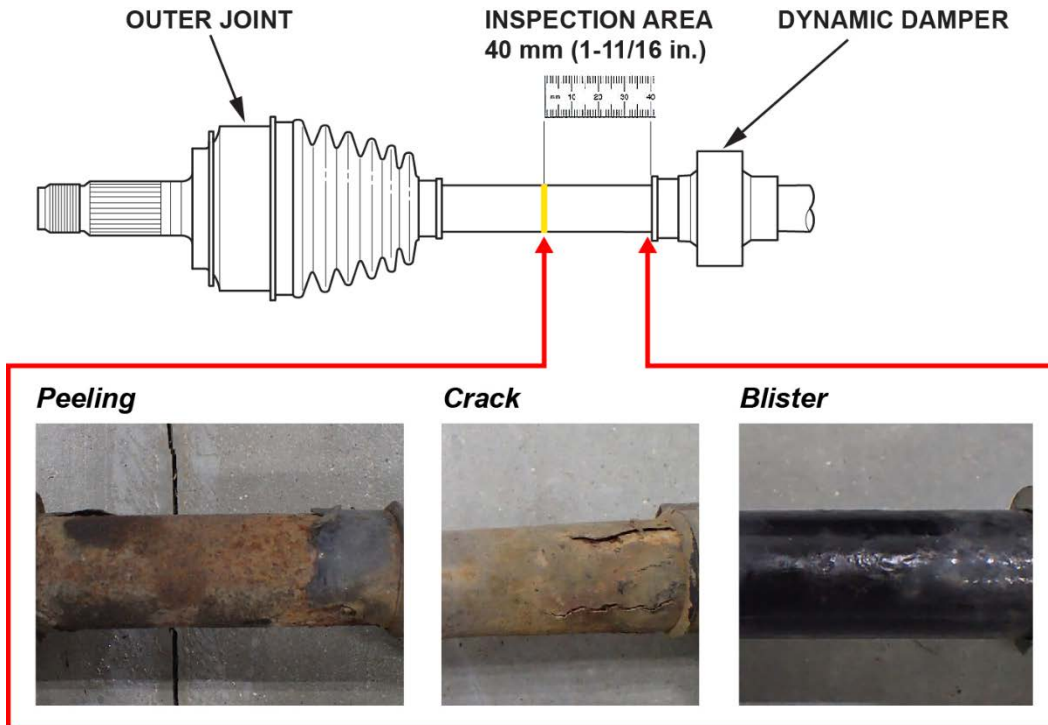
8. Inspect the driveshaft surface between the dynamic damper and the line for peeling paint, cracks, or blisters. Corrosion or paint defects between the outer joint and the yellow line are OK.

Is there peeling paint, cracks, or blisters on either driveshaft within **40 mm (1-11/16 in)** of the dynamic damper?

Inspect both driveshafts for signs of corrosion or paint defects. Replace the right, left, or both driveshafts if there is corrosion, the paint is peeling, cracking, or blistering in the inspection area.

Yes - Go to REPAIR PROCEDURE.

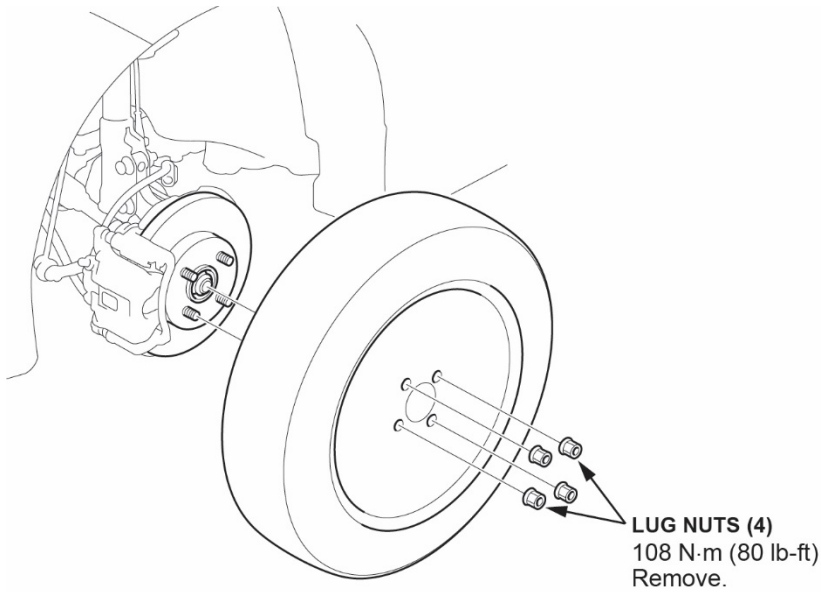
1. Remove the front wheel of the driveshaft you are replacing.

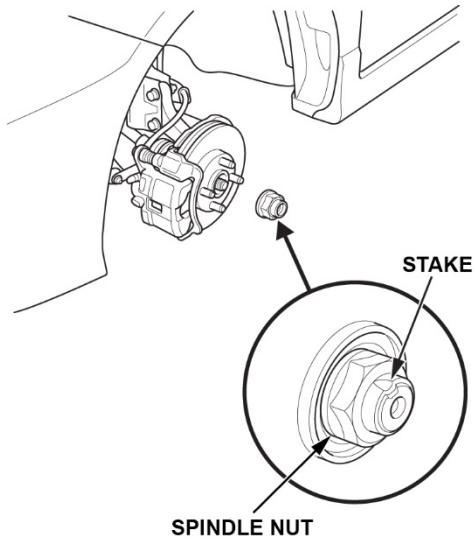
2. Pry up the stake on the spindle nut, then remove it.

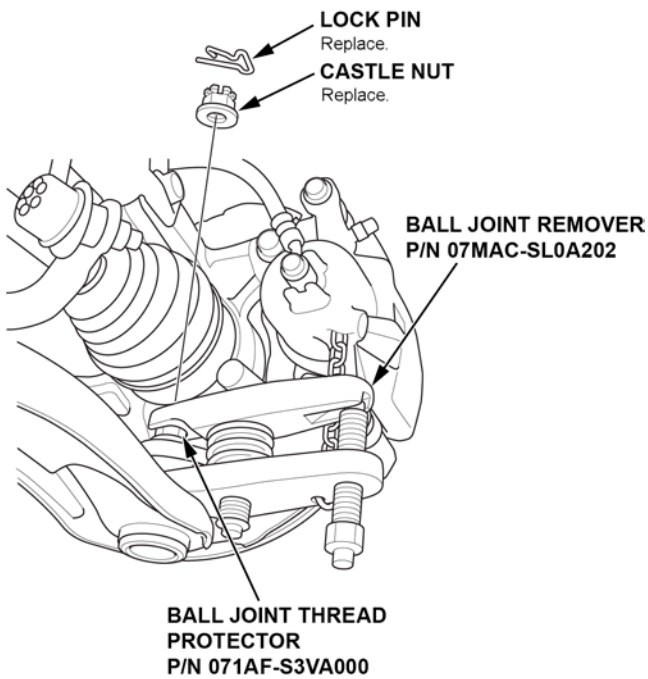
3. Remove the lock pin from the lower arm ball joint, then remove the castle nut.

4. Separate the ball joint from the knuckle using the Ball Joint Thread Protector (T/N: 071AF-S3VA000) and Ball Joint Remover (T/N: 07MAC-SL0A202). Grease the threads and tip of the pressure bolt on the ball joint remover, and make sure the pivot bolt is not parallel to the ball joint remover arms. For additional information on how to use the tools, refer to the service information.

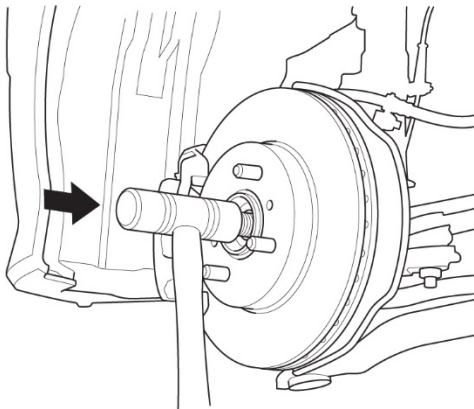
5. Use a soft-face hammer to separate the outboard joint from the front hub.

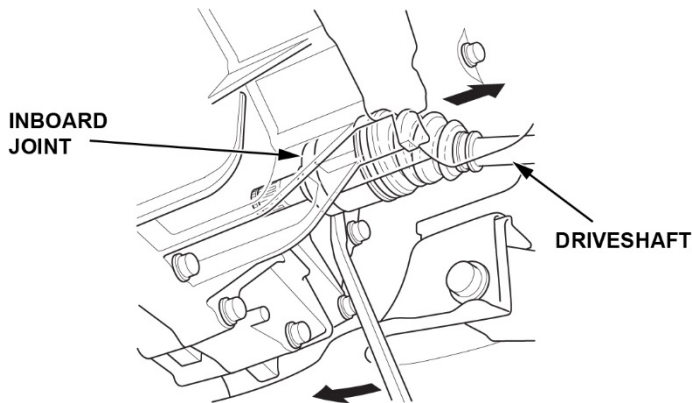
7. *Driver's side driveshaft only:* Use a pry bar to pry the inboard joint from the transmission housing. Then, remove the driveshaft as an assembly.

- Do not pull on the driveshaft, or the inboard joint may come apart.
- Pull the inboard joint straight out to avoid damaging the oil seal.
- Be careful not to damage the transmission oil seal with the pry bar.

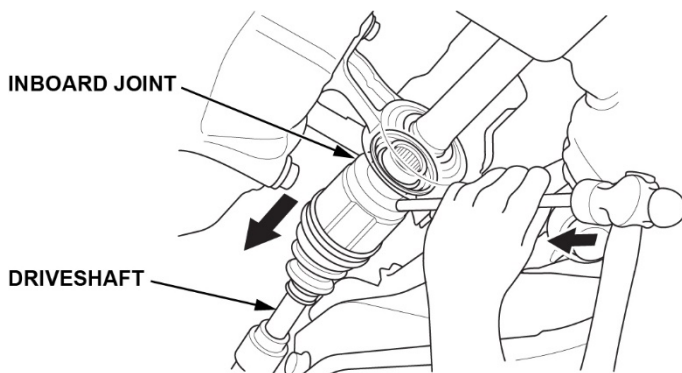
8. *Passenger's side driveshaft only:* Using a punch and hammer, drive the inboard joint off of the intermediate shaft. Then, remove the driveshaft as an assembly.

- Do not pull the assembly by the driveshaft, the inboard joint may come apart.
- Be careful not to damage the transmission oil seal with the pry bar.

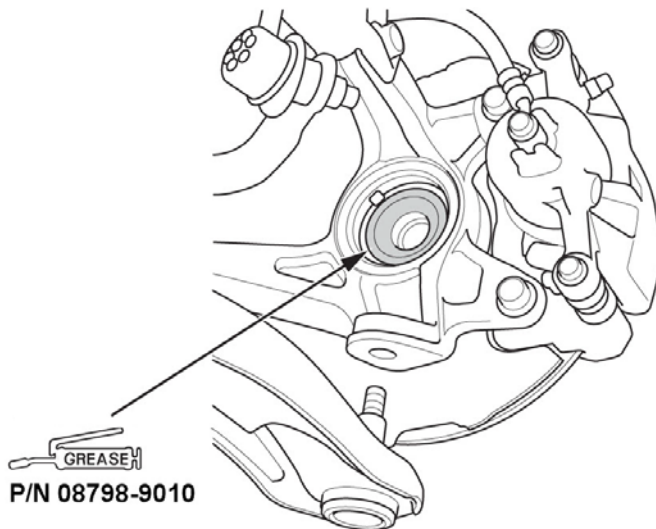
12. Apply about **5 g (0.18 oz)** of M-77 Assembly Paste (P/N 08798-9010) to the contact area of the outboard joint and front wheel bearing.

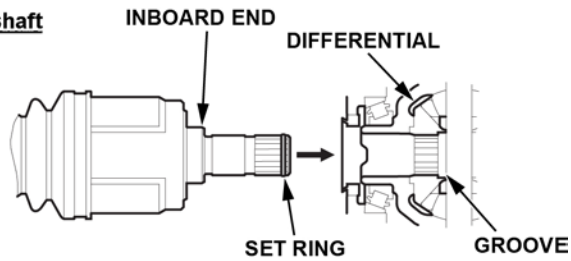
**Driver's Side Driveshaft**

13. Insert the inboard end of the driveshaft into the differential or intermediate shaft until the set ring locks in the groove. Make sure to insert the driveshaft(s) straight in to avoid damaging the oil seal.

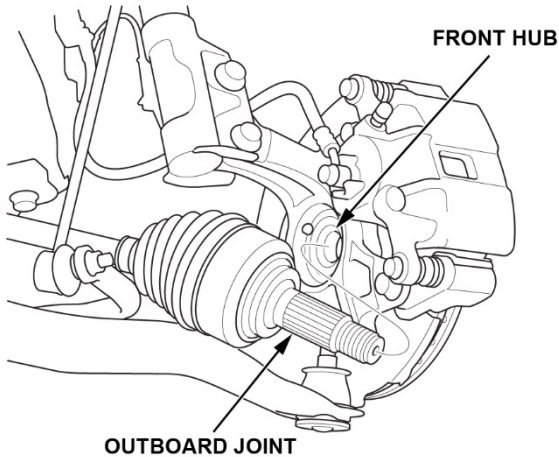
14. Install the outboard joint into the front hub on the knuckle.

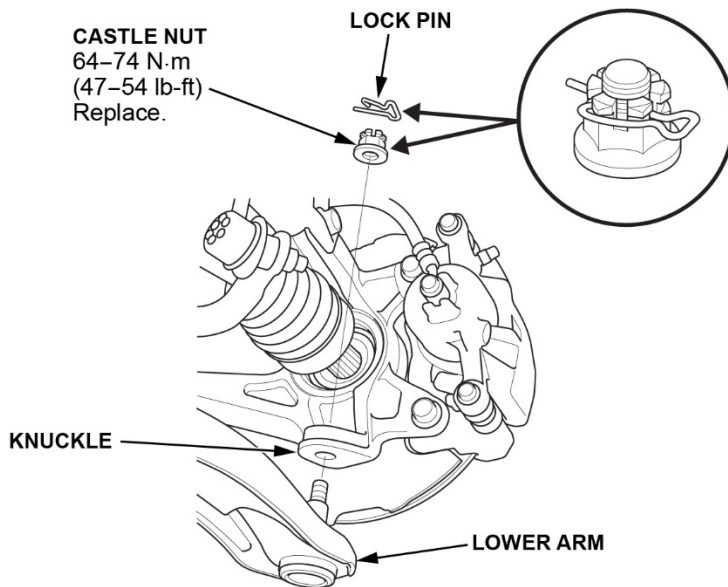
15. Wipe off any grease contamination from the tapered ball joint section and threads, then install the knuckle onto the lower arm. Make sure not to damage the ball joint boot.

16. Install the new castle nut, and torque it to the lower torque specification. Then, tighten it until the slot on the castle nut aligns with the ball joint pin hole. Install the lock pin into the pin hole as shown.

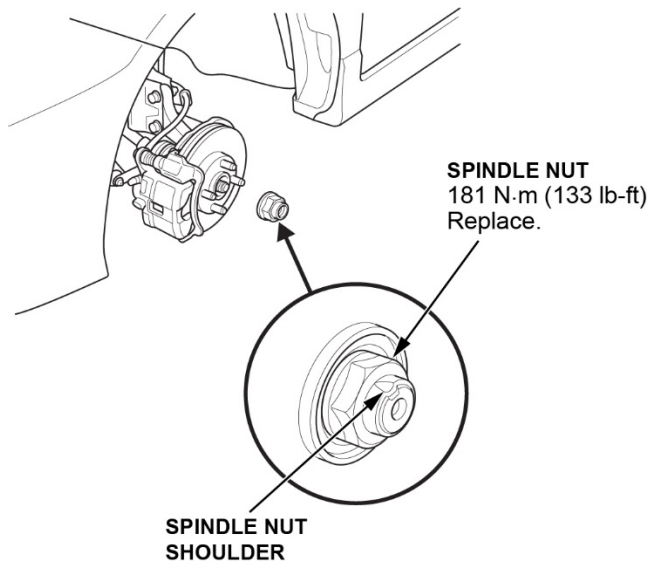
17. Apply a small amount of engine oil to the seating surface of the new spindle nut. Then, install and torque the spindle nut. After torquing it, use a drift punch to stake the spindle nut shoulder against the driveshaft.
